Learning from Other People's Mistakes

Most satellite mishaps stem from engineering mistakes. To prevent the same errors from being repeated, Aerospace has compiled lessons that the space community should heed.

Paul Cheng and Patrick Smith

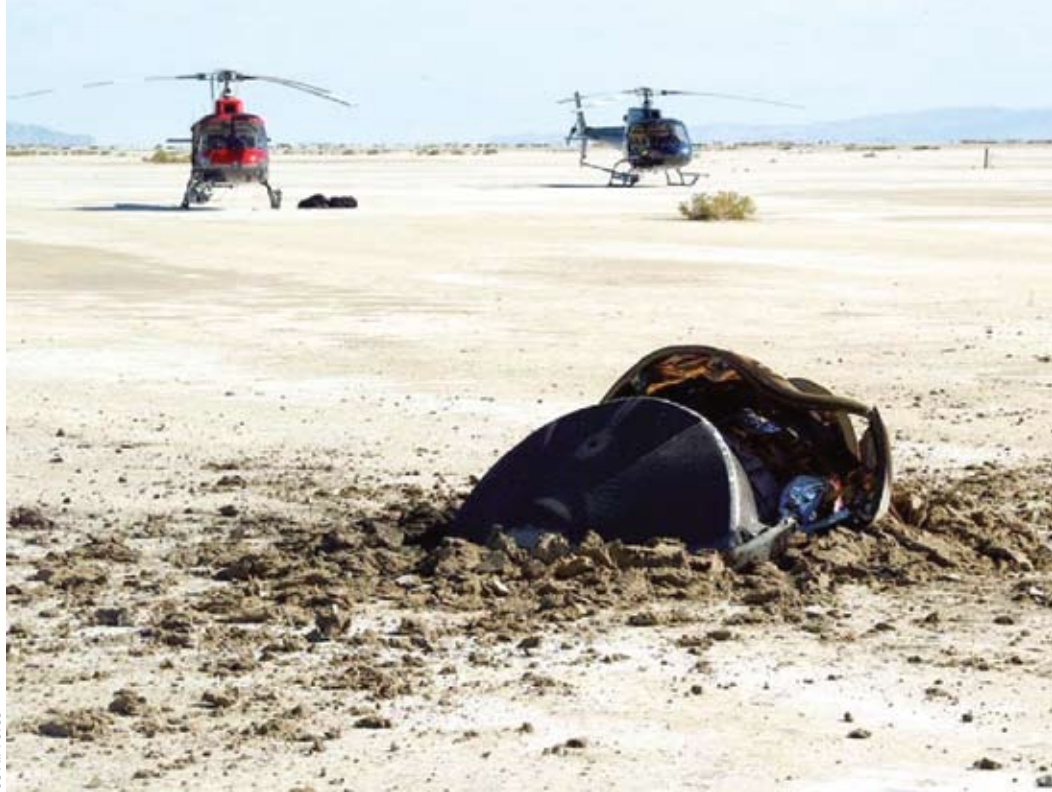
The Genesis capsule, embedded in the sands of Utah after its parachute system failed to deploy in September 2004. The Mishap Investigation Board said the likely cause was a design error involving the orientation of gravity-switch devices.

More recently, the Genesis spacecraft crashed. Genesis brought back solar-wind samples. During reentry, aerodynamic deceleration was supposed to cause a parachute to unfold. Genesis’s avionics design was derived from an earlier mission, Stardust, but was too complex to fit into Stardust’s one-box package. Genesis designers cut and pasted Stardust’s schematic into a new two-box design. The Stardust unit had been spin tested, but the two boxes in Genesis were difficult to spin together. So, believing that the design was flight proven, Genesis engineers simply verified the new assembly “by inspection.” Unfortunately, nobody knew that a pair of deceleration sensors were direction-sensitive—even the Stardust drawings did not flag any polarity constraint. The sensors were by chance turned sideways in the new layout, and as a result, the parachute could not open.

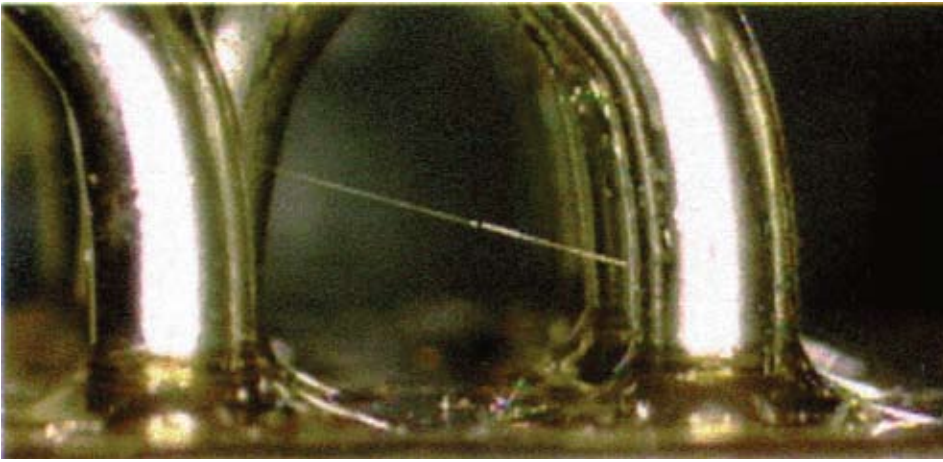
Pure tin plating can grow conductive whiskers. Numerous satellites have been disabled because whiskers inside the control processors caused plasma arcing that blew the fuses.

failures. Fuses, circuit breakers, and other devices are intended to protect upstream components, but careful design is required to prevent the safety devices from misbehaving. Plasma arcing most frequently results from pure tin plating that grows conductive filaments (commonly known as “whiskers”). Numerous satellites, such as Galaxy VII, had been disabled because whiskers grew on the relays of their control processors, causing arcing that blew the fuses.
